Research Report
UKTRP-84-28

JACKSON PURCHASE PARKWAY PAVEMENT STUDY

James H. Havens
Associate Director

Kentucky Transportation Research Program
College of Engineering
University of Kentucky

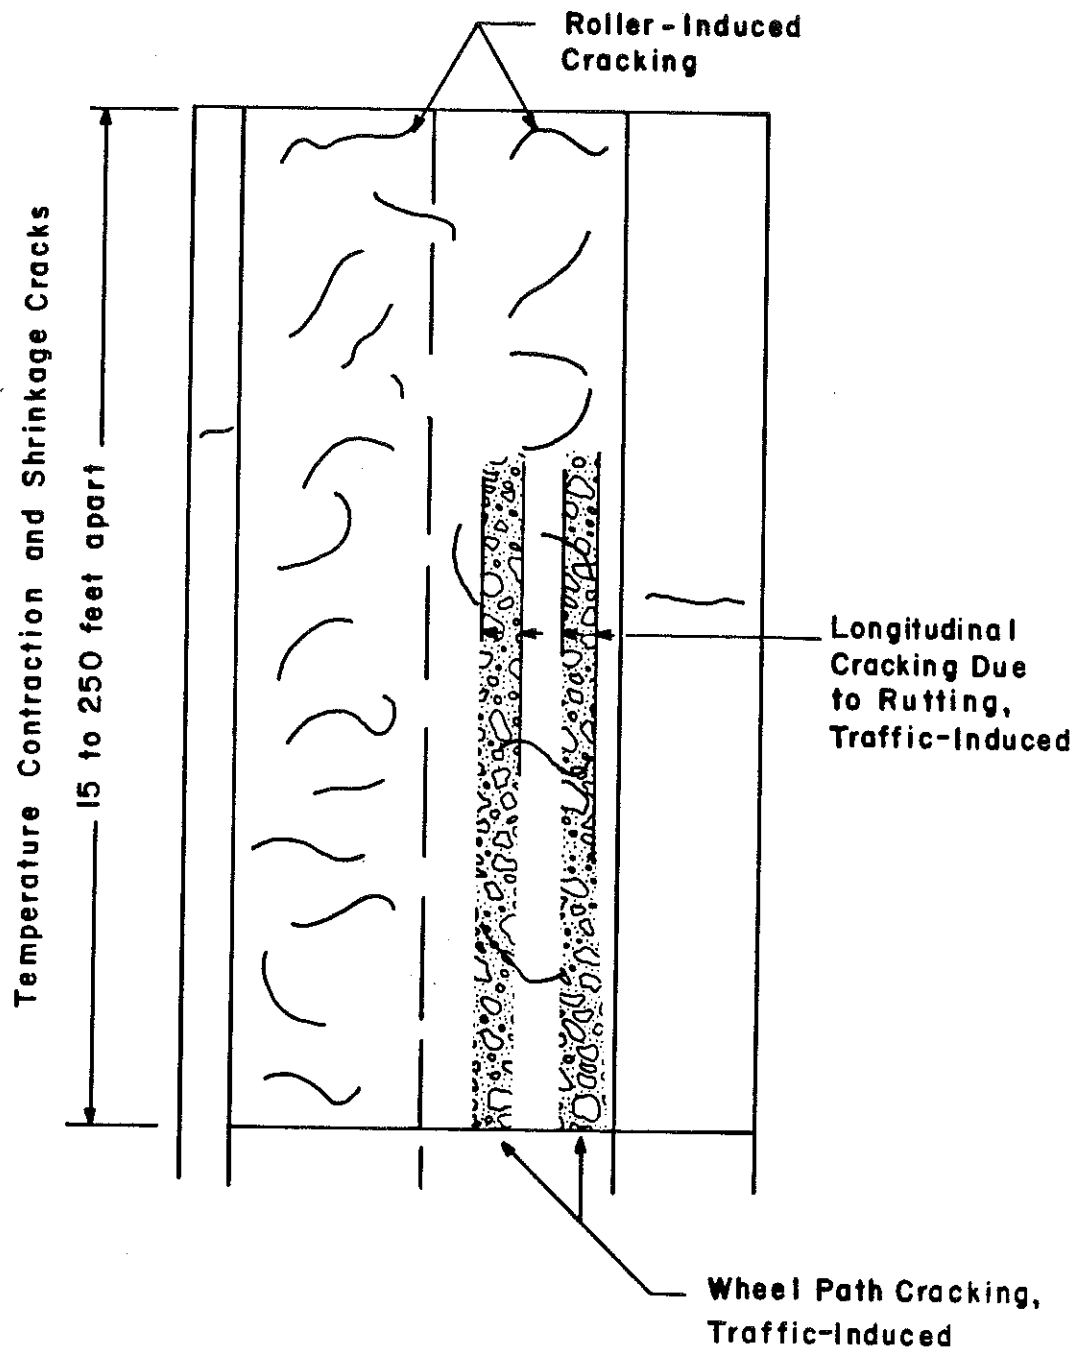
Figure 2. Four Distinct Patterns of Cracking on Jackson Purchase Parkway. Only wheel path cracking was unique there, and it was limited to the all-gravel section south of the Graves-Fulton County line.

Four distinct patterns of cracking were observed on the Parkway. They are illustrated by Figure 2. Only that pattern identified as wheelpath cracking was unique to the all-gravel section south of Bayou du Chien (Graves-Fulton County line). The other three patterns persist throughout the Parkway and are likely to be found in many, if not all, asphaltic concrete pavements of some age in any part of the state. Further description follows.

Roller-induced cracking is illustrated in Figure 2. It occurs not only south of Bayou du Chien but northward also -- nor does it stop at the north end of the Parkway. It may beset many asphalt surfaces not otherwise suspect. It occurs (with other cracking) on KY 676, on the west side of the river, at Frankfort. Intense cracking of this type has been observed on KY 627 from Boonesborough toward Winchester.

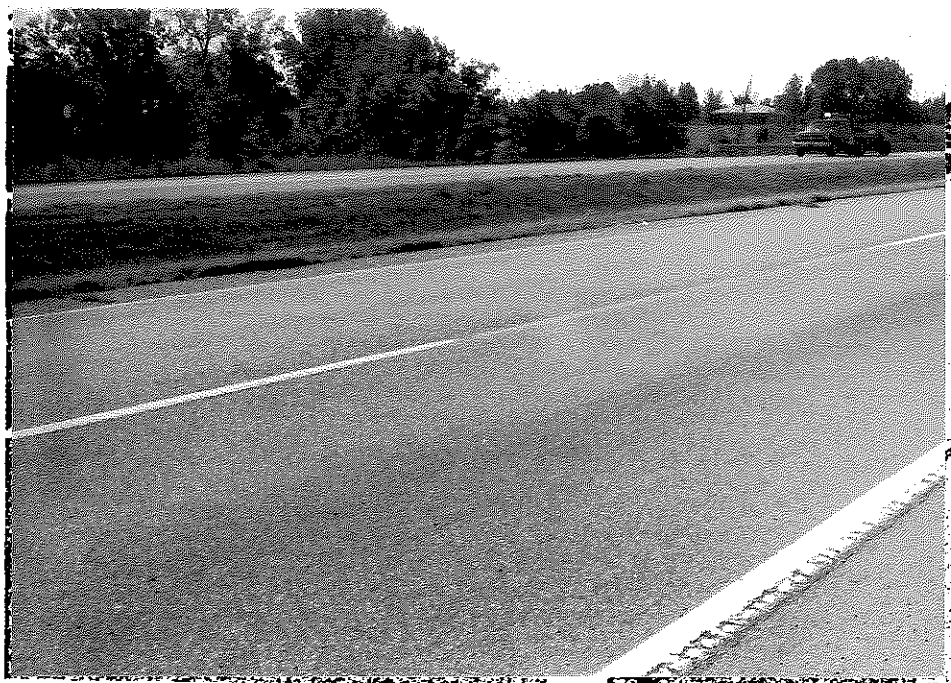
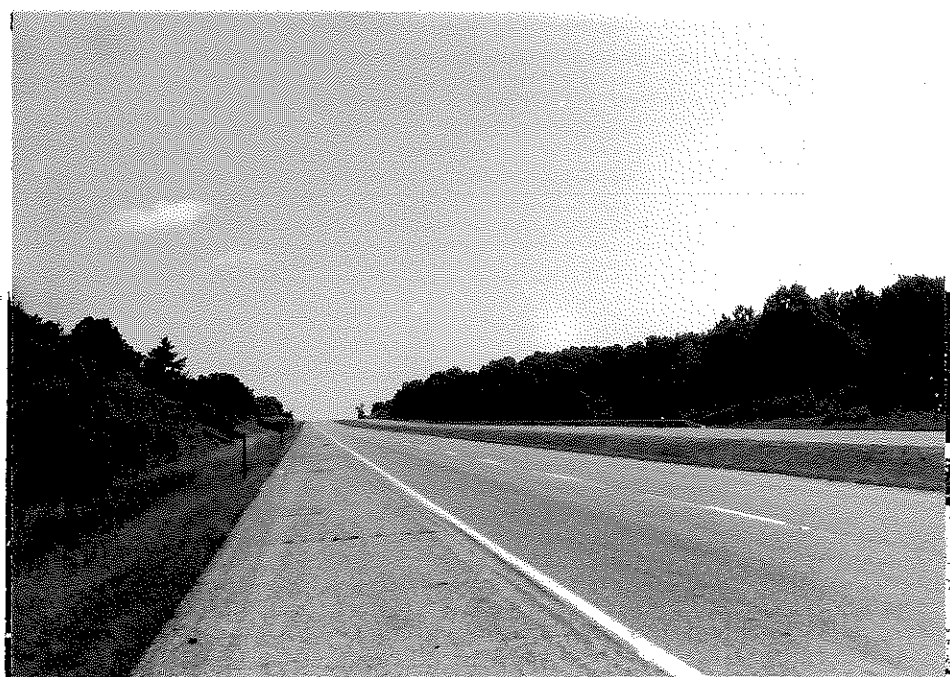
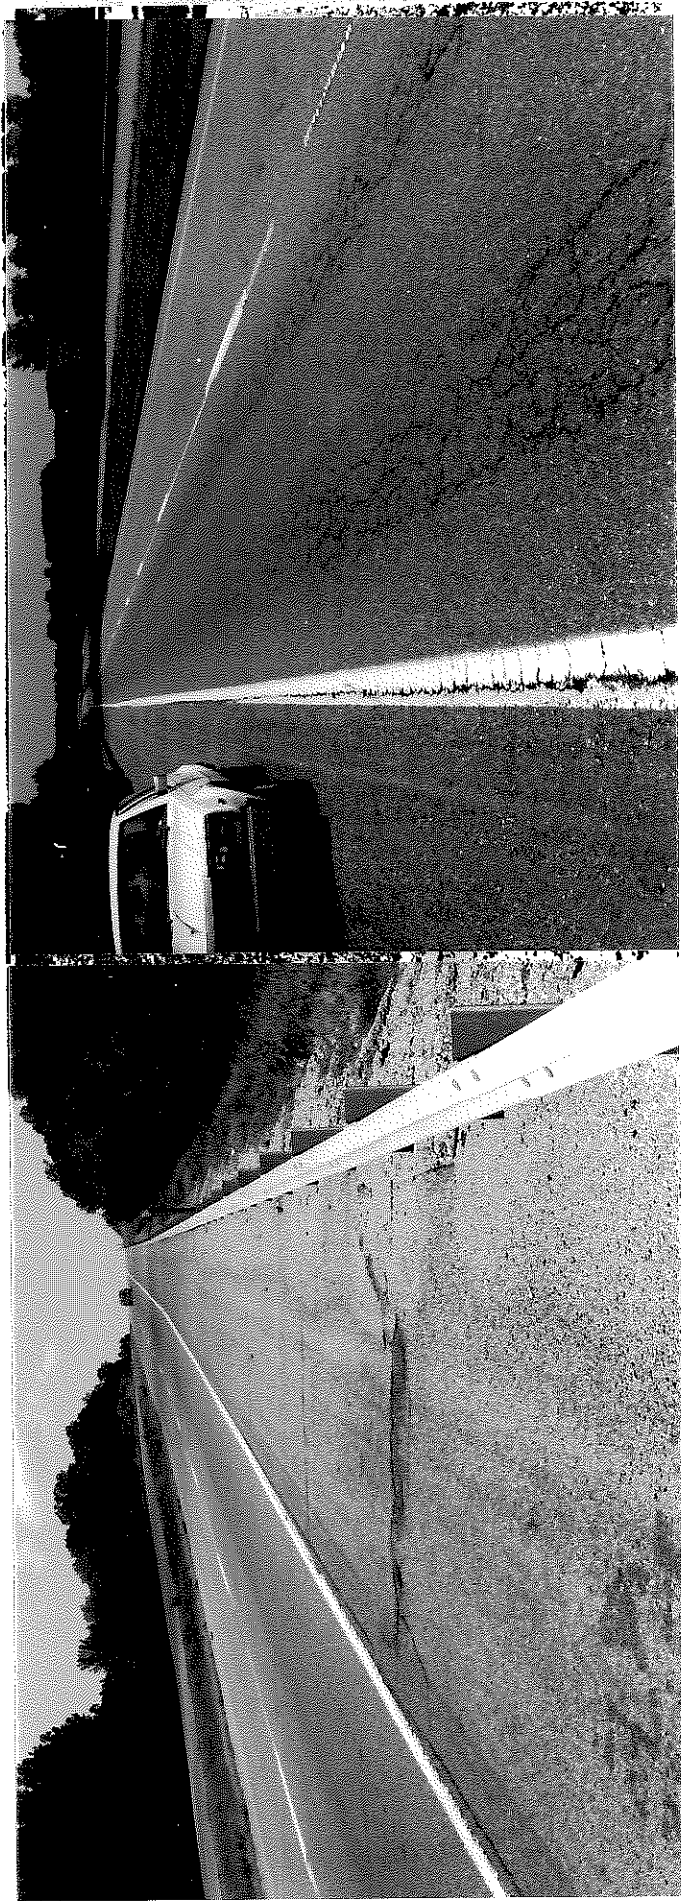
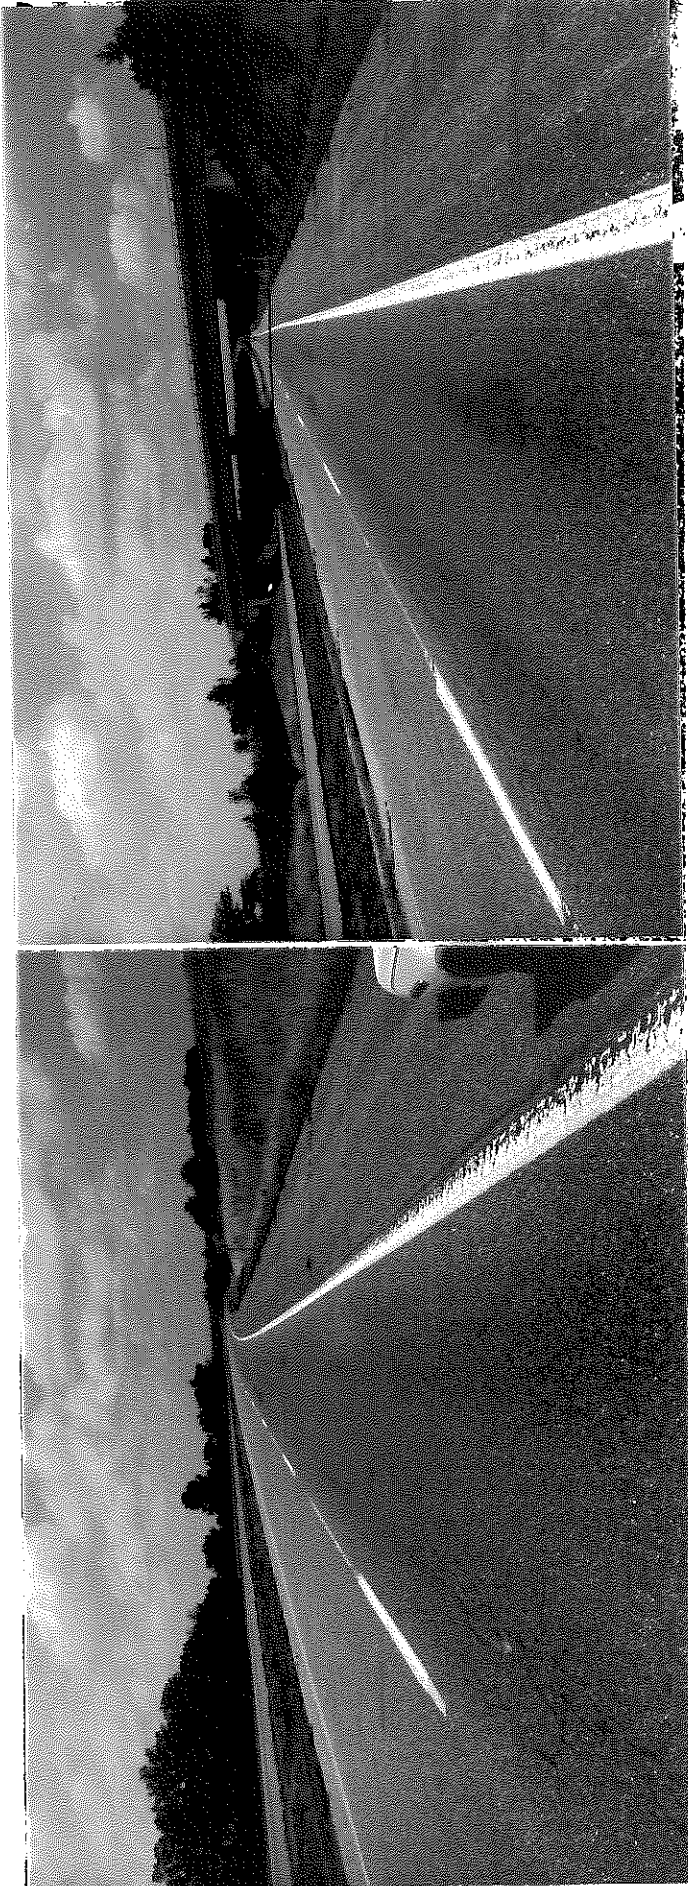
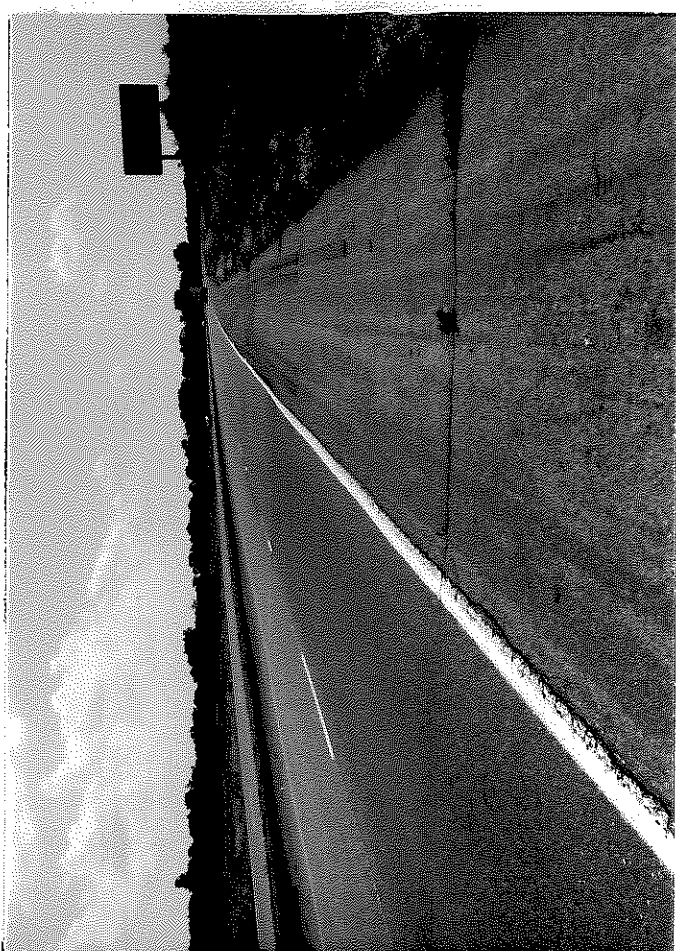
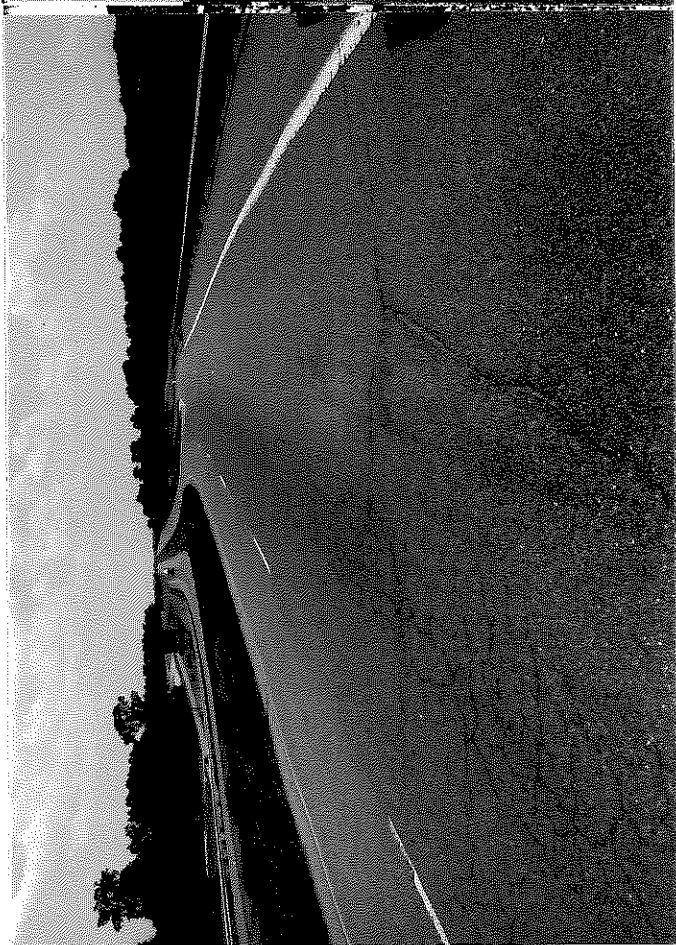
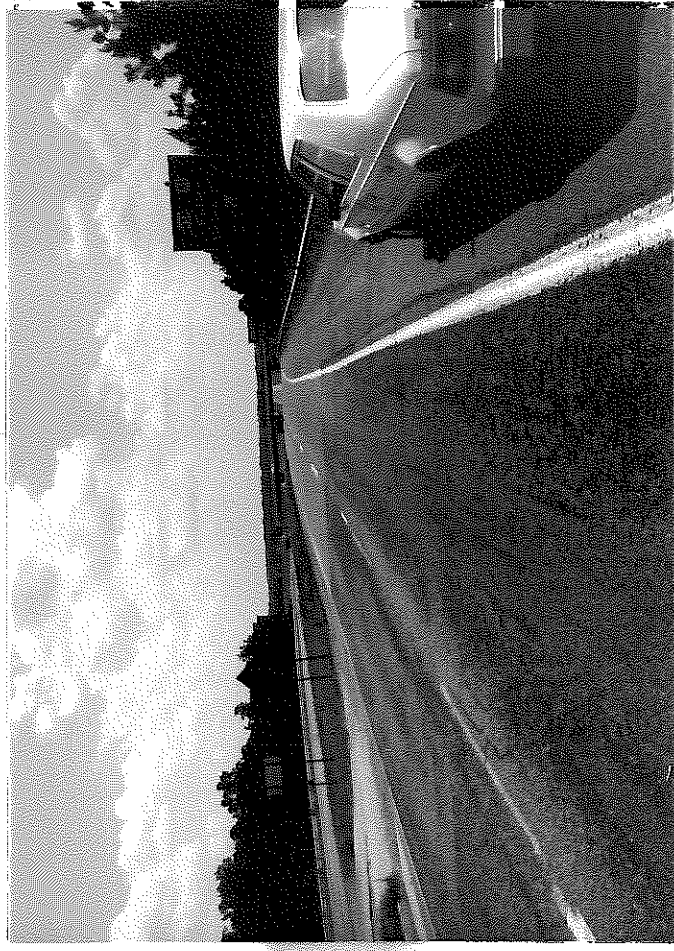
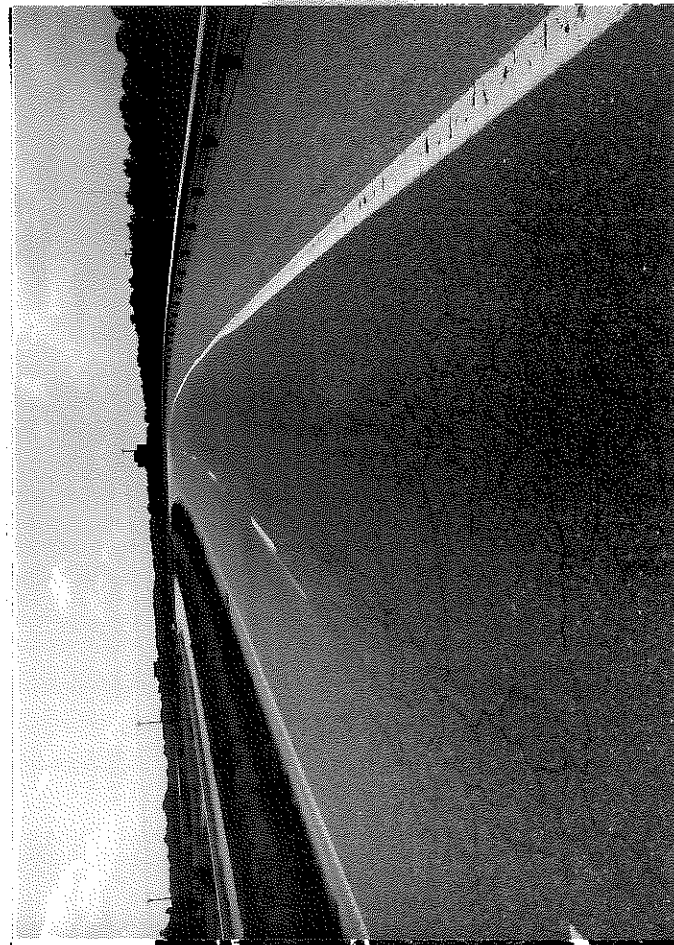
Photographs Taken July 10, 1984

Our inspection was made on July 10, 1984. Interval cracking (due to temperature and/or shrinkage) was anticipated; and several one-mile samplings were counted as we traveled from the US 62 junction southward. This type of cracking varied from site to site but persisted throughout. Only south of Bayou du Chien (Hickman-Graves County Line) was the severe map cracking in the wheelpaths so obvious. The cracking there is distinctively load-associated and appears to be due to weakness in the cement treated base. Weakening may have occurred too in the bituminous surface and base courses. Fatigue is the probable, failure mechanism. Only a small chunk of the cement-treated gravel base was recovered from the coring done July 20. It was excessively sandy.

2. Transverse: Very prominent throughout -- nearly straight line cracking across pavement (perpendicular to centerline), oftentimes in line with cracks extending through outside and inside shoulders, frequently grass is growing in both shoulder cracks. Sometimes cracks in shoulders do not coincide with cracks in mainline pavements. These are typical temperature cracks and shrinkage cracks. They are not altogether reflection cracks

3. Random, Irregular Cracking: Thought to have been initiated at the time of rolling and compacting surface course. Weathering and erosion have made them obvious. These cracks were observed within two years after construction. They are not load-related. This is the typical pattern observed on I 64 in Clark-Montgomery Counties and which led to overlayment because of eligibility under pre-1964 construction program. This pattern has been observed elsewhere also.

4. Wheelpath Cracking: Believed to be a punching-shear (sometimes called "punch out") attributable to weakness and (or) overload of the pavement. May be related to fatigue and (or) weathering of layers.

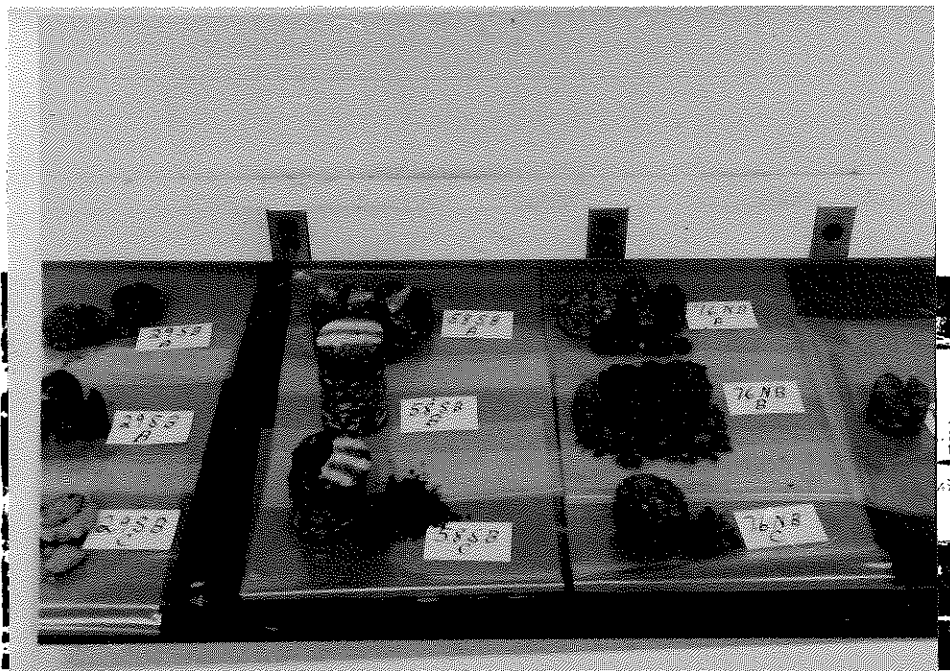
Cores Taken July 20, 1984

Cores were drilled July 20, 1984. A few cores were taken on the Mayfield By-Pass approximately a year previously but this location and conditions were not recorded for retrieval. Verbal reports implied that the cracks went full depth and were wider at the bottom than they were at the top. In speaking of cores taken of a crack zone, the nature or pattern of the crack was not described. It seems entirely possible that temperature (or shrinkage) cracks could exhibit that characteristic due to deterioration progressing at the bottom of the layer.

It should not be presumed that stripping caused failure; some stripping may accompany failure. It is not clear whether the stripping observed resulted from load stressing or affinity of chert surfaces for water. It seems that affinity would have created far more bare aggregate than was observed in the cores (very disaggregated, rubbly pieces).

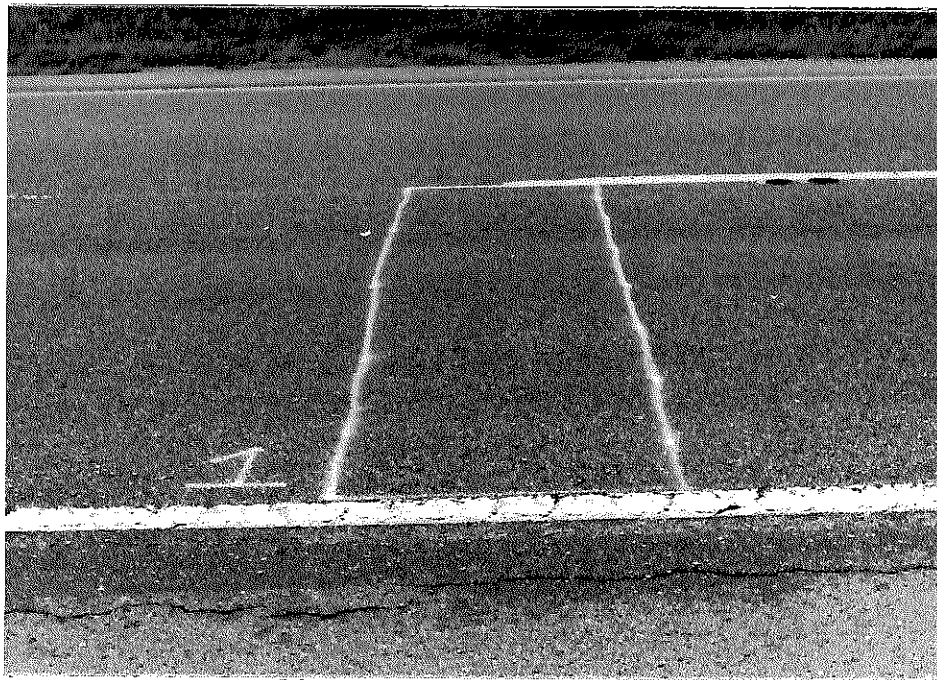
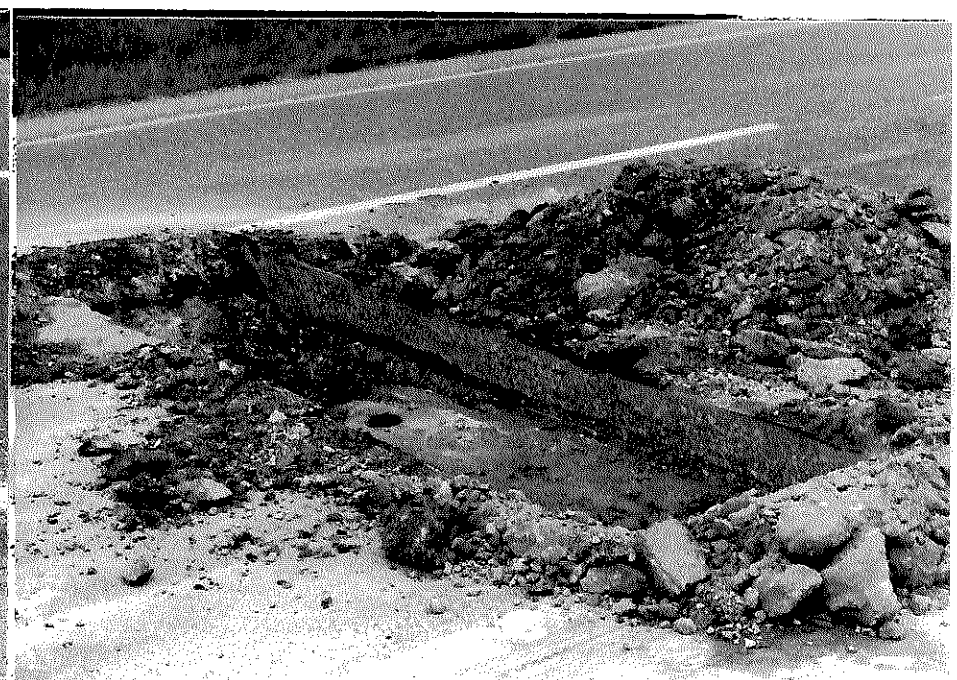
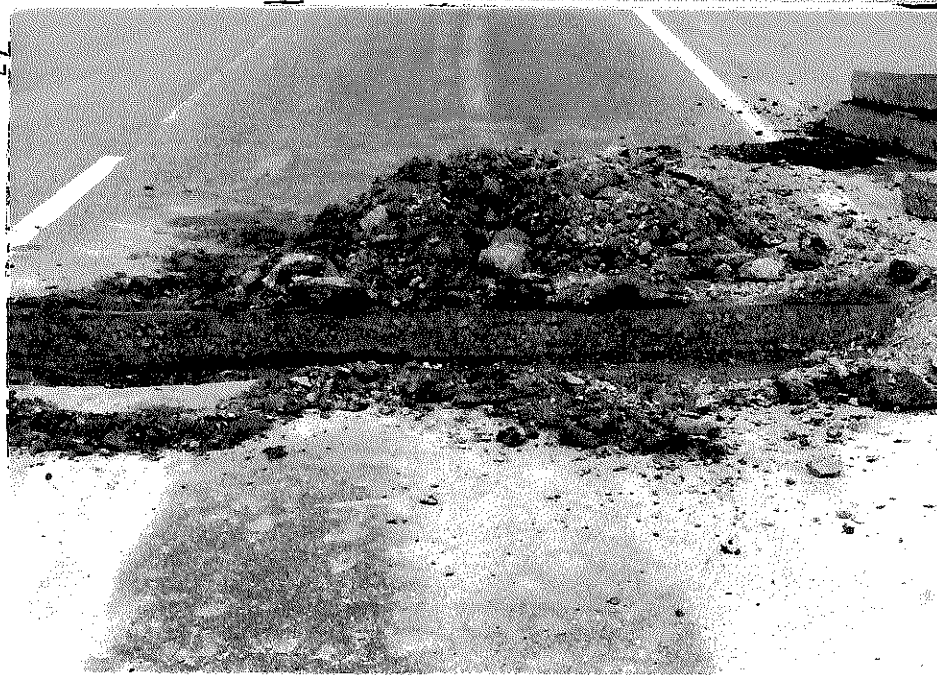
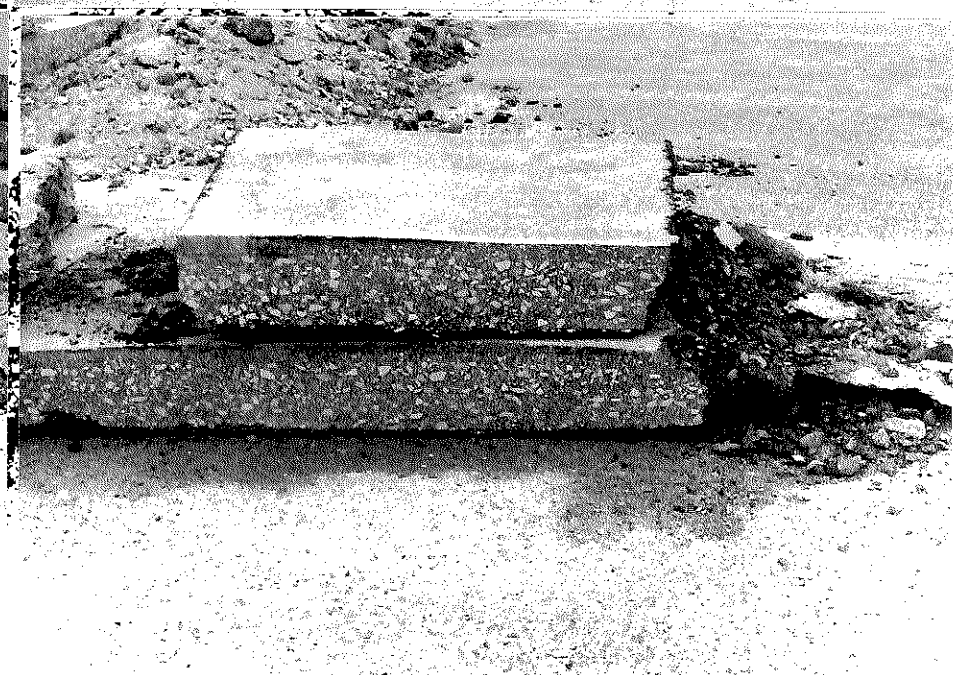
Site 1. Immediately North of Graves-Hickman County Line; Chosen as Control Site; Bituminous Concrete Composed of Crushed Limestone and Partially Crushed Gravel; August 8, 1984.

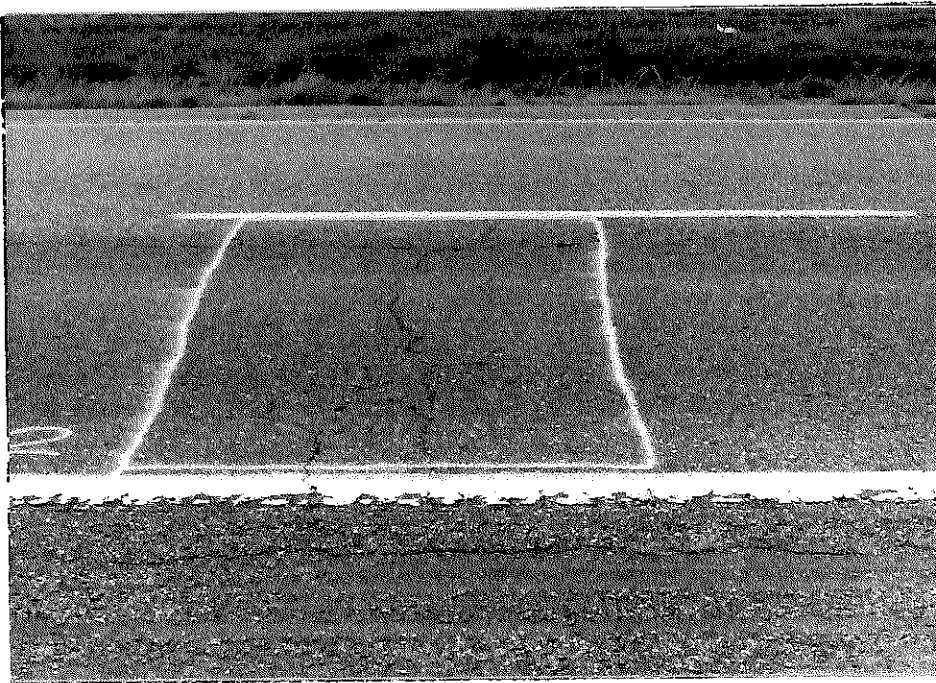
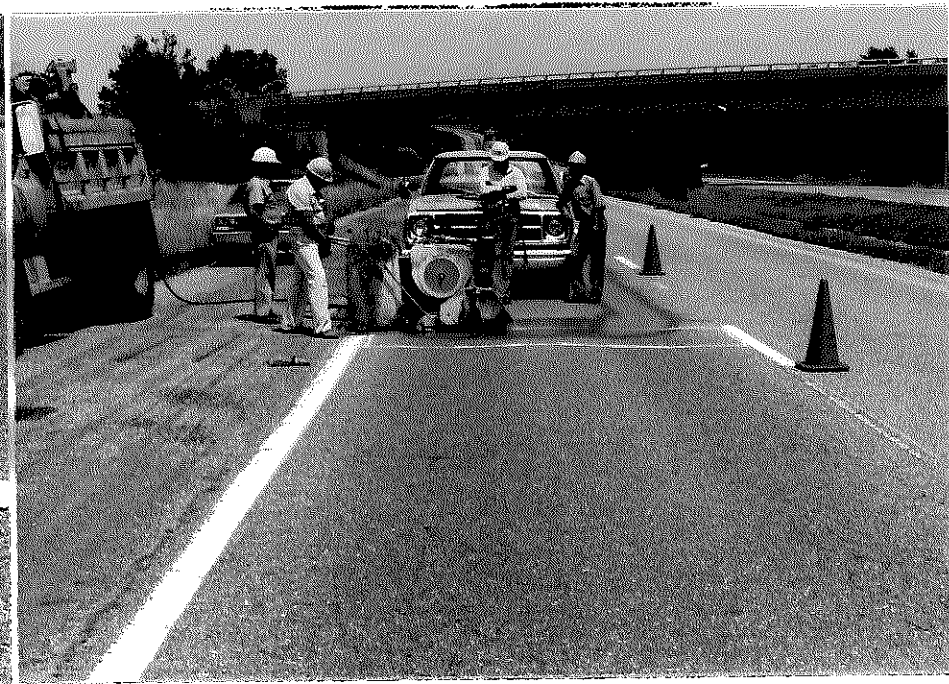
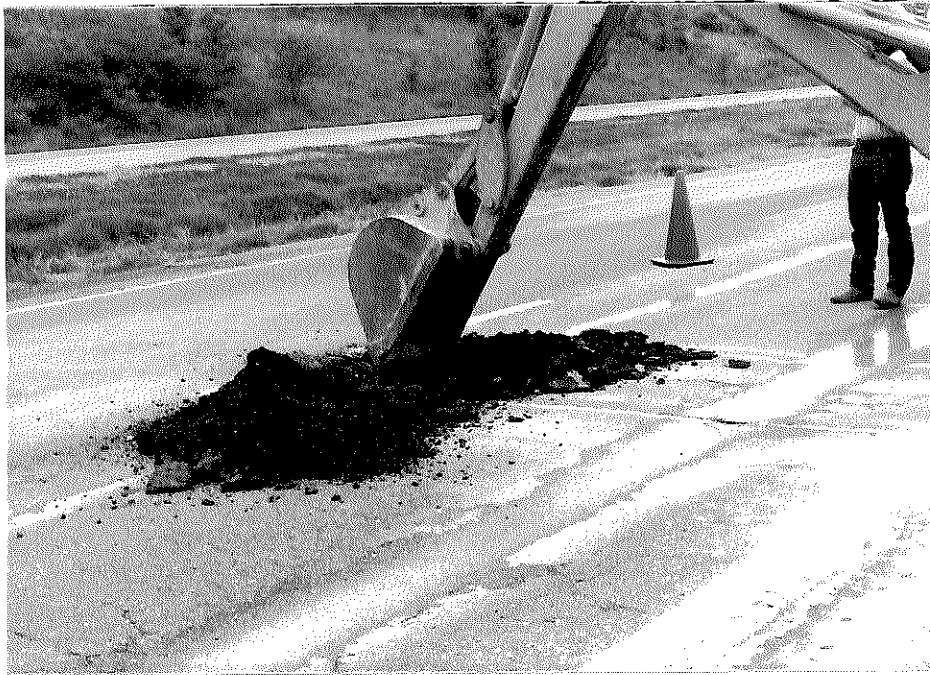
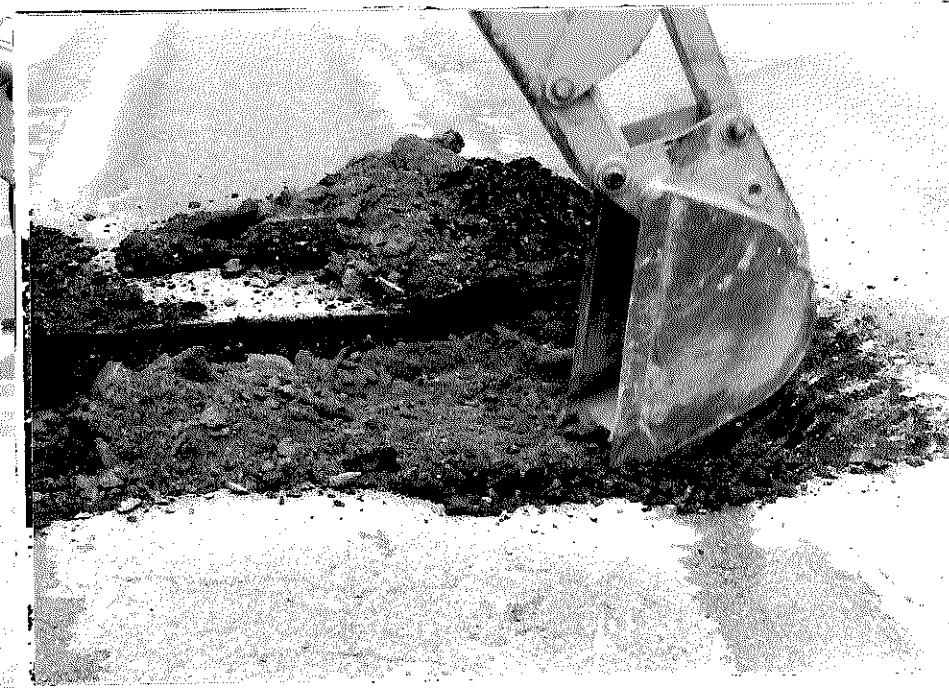
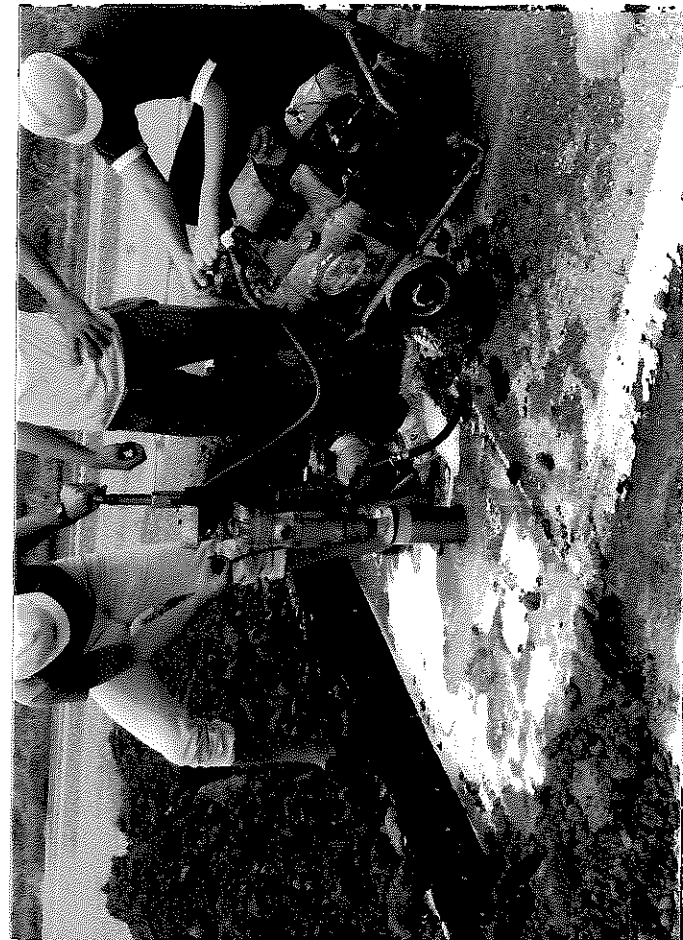
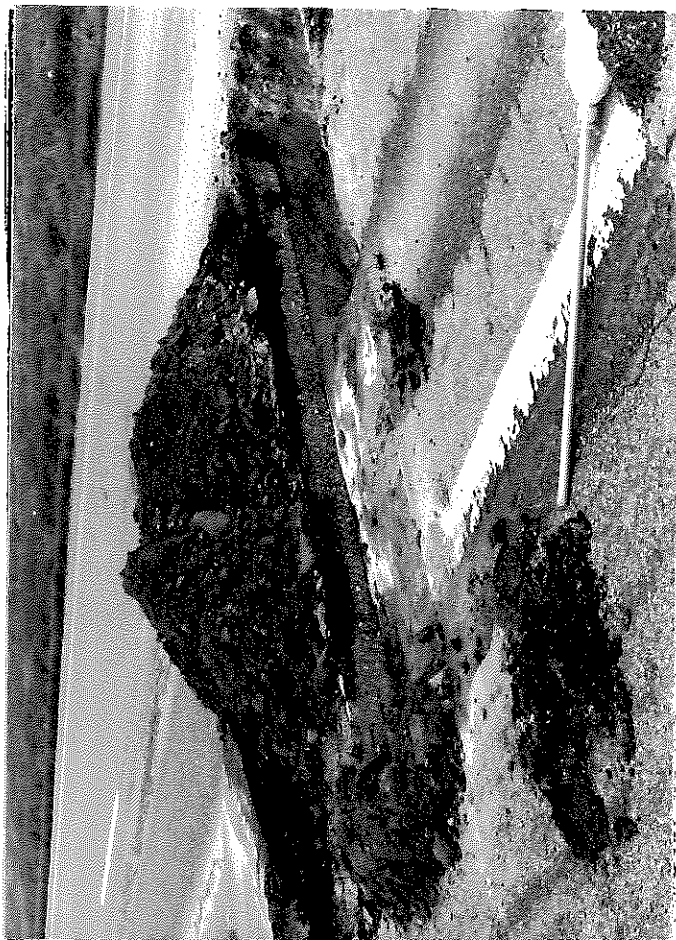
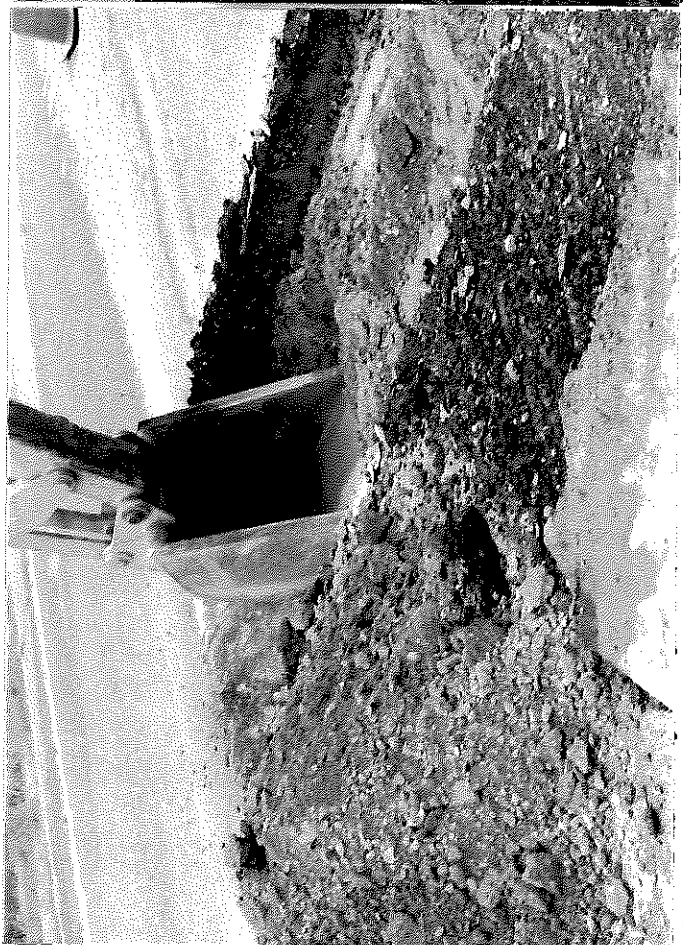
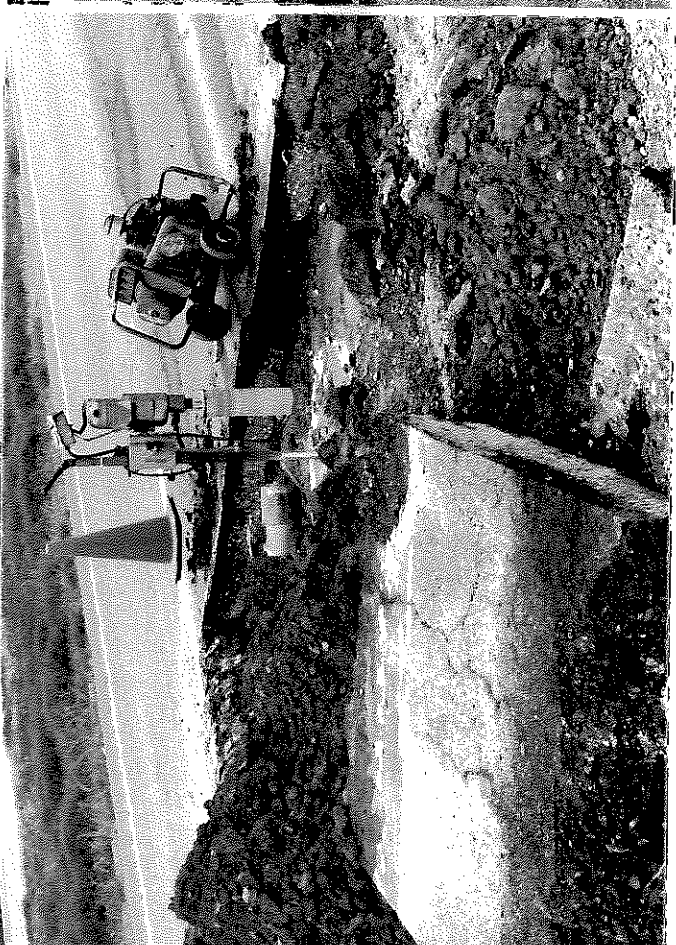
Site 2. Immediately South of Hickman County Line; Section Showed Transverse Shrinkage Crack; Gravel Aggregate; August 8, 1984.

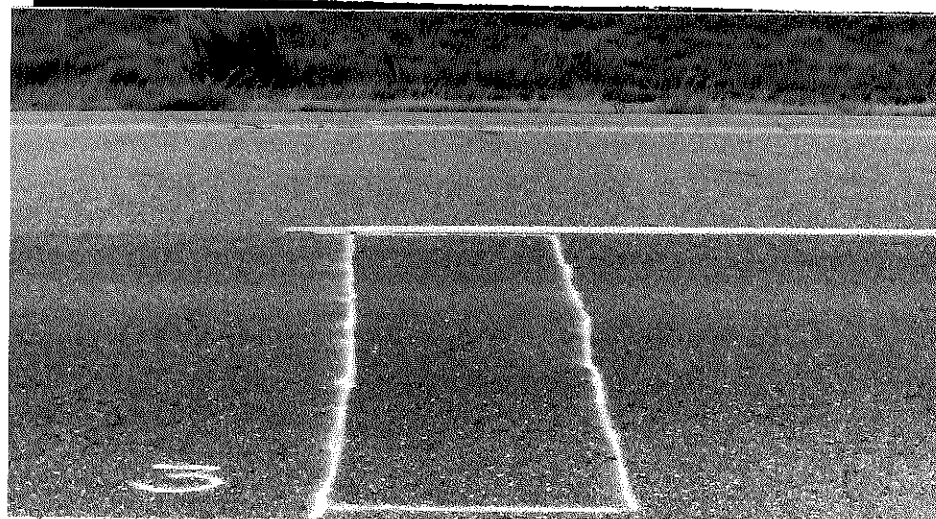
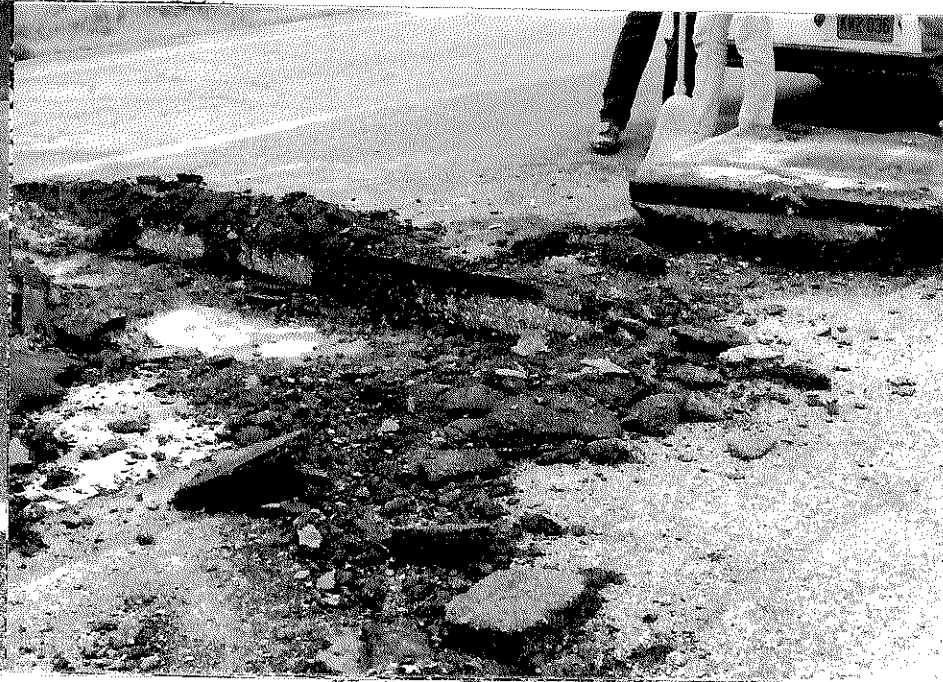
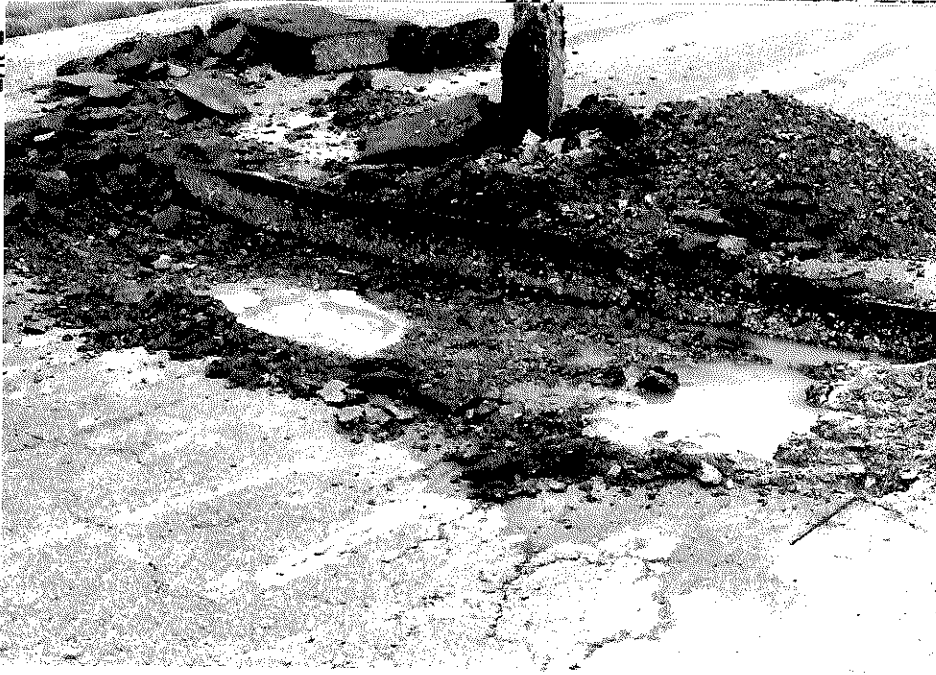
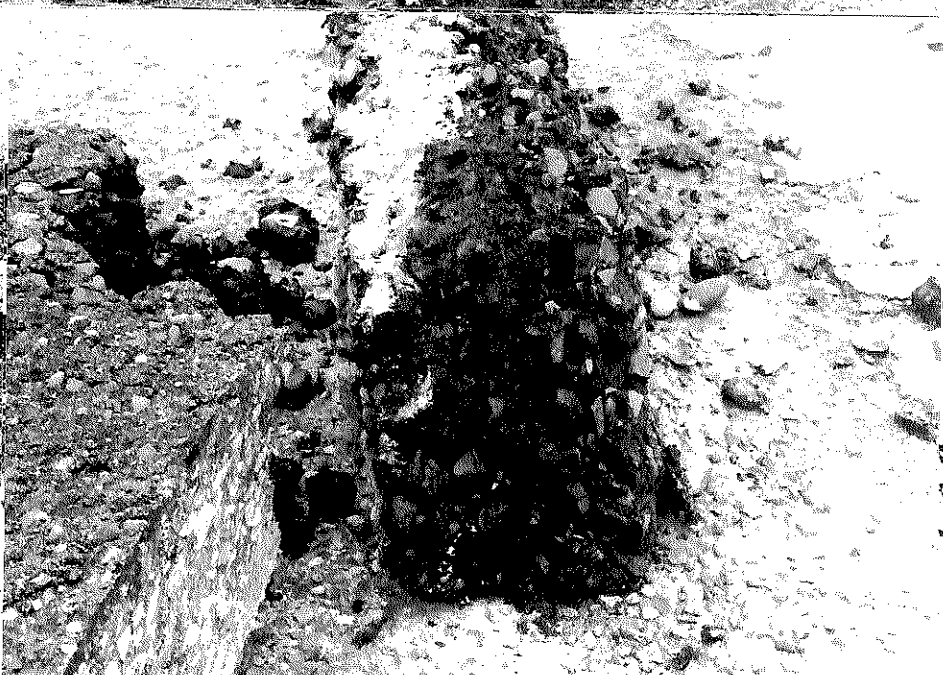
Site 3. 500 Feet Southward from Site 2; No Transverse Cracking; Cracking in Wheelpaths; August 8, 1984.

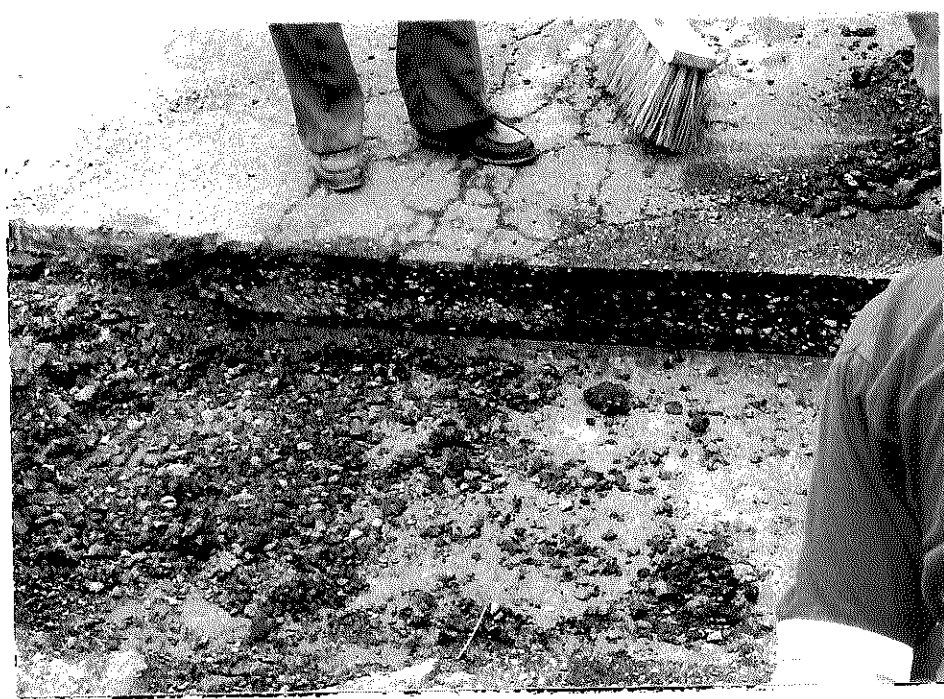
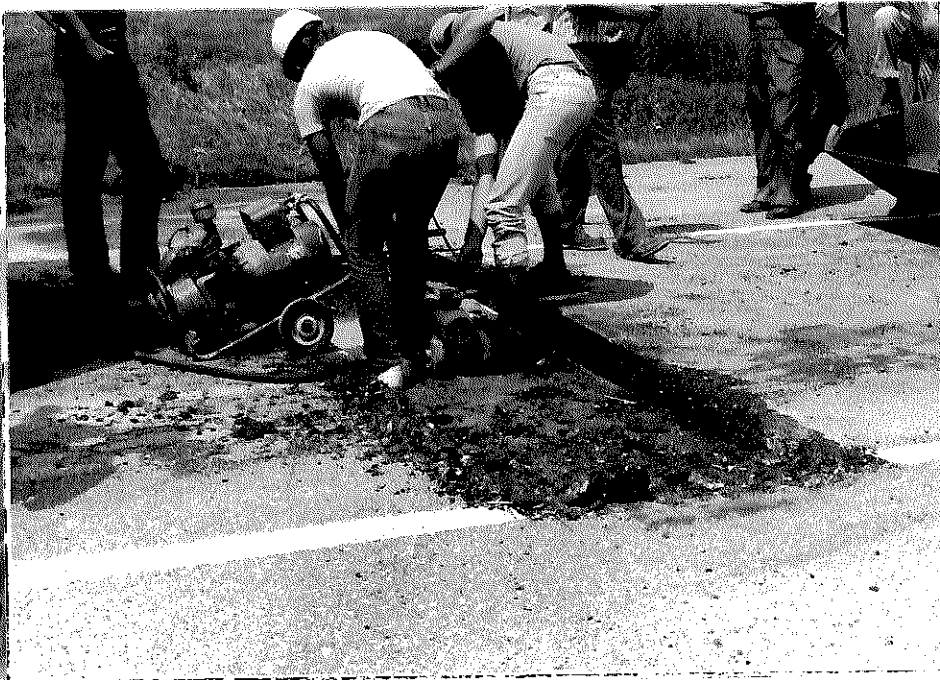
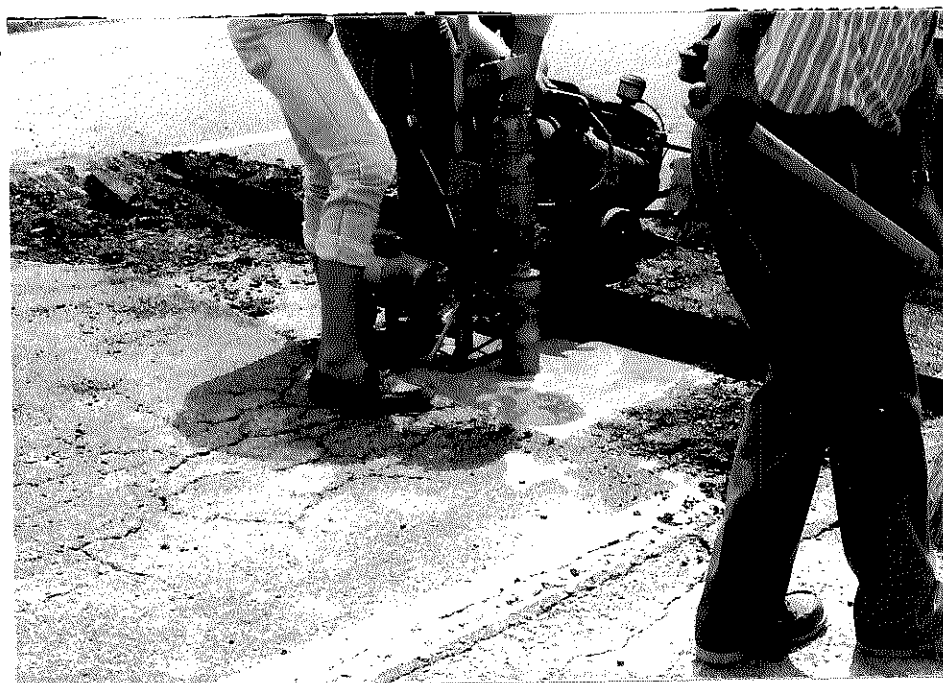
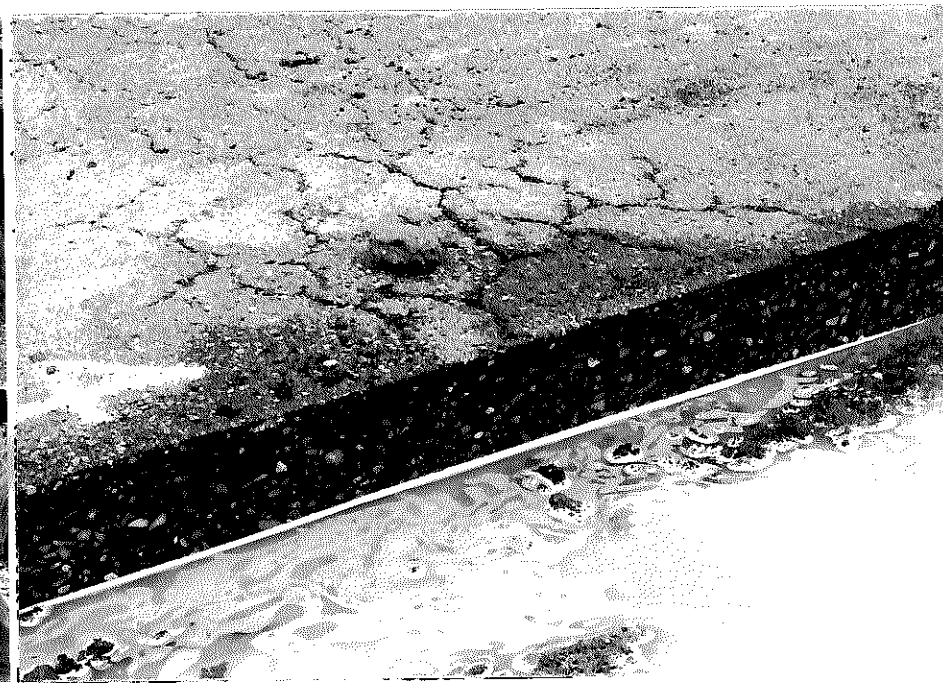
The thickness of asphaltic concrete at M.P. 1.75 was found to be nominally 1 inch thinner than was found by coring and trenching between M.P. 8 and M.P. 9.

Site 4. JPP MP 1.75, Southbound Toll-Free Section; Cracking in Wheelpaths; August 8, 1984.
